The Use of Crosshole Tomography to Evaluate Drilled Shaft Repairs

Les R. Chernauskas¹, M. ASCE, P.E. and Edward L. Hajduk², M. ASCE, D.Eng, P.E.

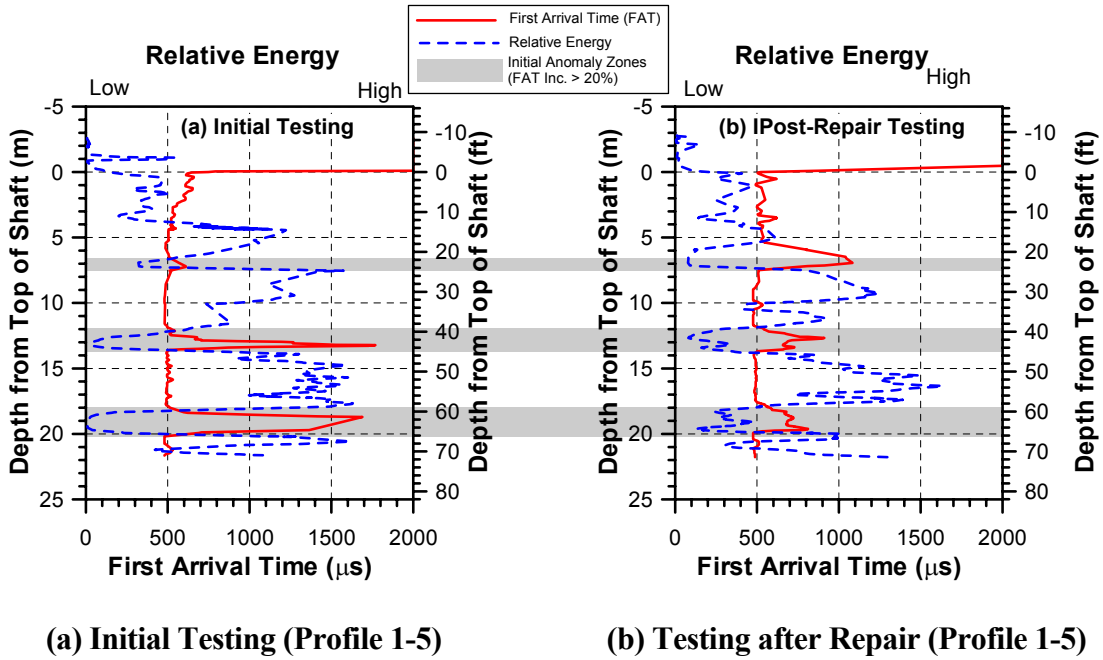
Figure 5. CSL Testing Results with Depth for Case History 1.

The initial CSL and CT testing performed on the shaft indicated significant anomalies defined by increases in FATs typically greater than 100% and very weak energy levels. Three major anomalous zones, in the shape of “hockey pucks” around 0.9 to 1.8 meters thick, were detected in most tube profiles at approximately 9.8, 15.5, and 21.6 meters below the top of the steel casing. Figures 5a and 6a present the initial CSL testing results (FAT and relative energy) and 2D vertical CT results (apparent velocity), respectively, for a selected access tube combination across the drilled shaft. Figure 6a also presents the initial 2D horizontal (i.e. plan view) CT test results at the three major anomaly zones. As shown in Figure 6a, the upper zone does not appear to contain as much lower strength concrete, as represented by blue and green areas (velocities around 2,300 to 3,000 m/s) compared with the red and blue areas in the middle and lower zones (velocities around 1,500 to 2,300 m/sec).

of approximately 9 to 26 meters. The cores revealed weaker and segregated concrete in three major zones at depths that correlated well with the anomalous zones identified by

the CSL/CT testing. The results of the core testing indicated that the concrete compressive strengths typically ranged between approximately 4 and 18.6 MPa in the anomalous zones and between 31 to 44.9 MPa elsewhere.

CSL and CT testing was performed four (4) days after the completion of the repair of the last (i.e. upper) zone. The post-repair CSL and CT results are shown next to the initial testing results in Figures 5b and 6b, respectively. As shown in Figures 5 and 6, improvements (i.e. decreases in FAT, increases in apparent velocities and relative energy) were observed in the lower two anomaly zones. The velocities in the lower two anomaly zones typically increased to around 2,500 to 3,000 m/sec. The upper post-repair zone indicates a slightly thicker zone with lower velocities than those determined during the initial testing. The greater thickness of the upper zone is most likely a result of the high pressure cutting procedure used to remove the concrete, where additional “good quality” concrete may have been removed at the upper and lower boundaries. The higher FAT increases and lower velocities in the upper zone are most likely due to the shorter grout curing time of approximately 4 days as compared to several weeks for the lower zones. The compressive strengths determined from the post repair core samples indicated grout compressive strengths around 27.6 MPa after 7 to 10 days and over 34.5 MPa after 14 days. Based on the CSL/CT results in conjunction with QC/QA testing of the grout materials, the drilled shaft repair was considered to be successful.

The primary repair procedure involved using a high pressure head to blast out concrete in the three defective zones. Nozzle pressures upwards of 140 MPa were used to cut away and flush out the defective concrete. Remote inspection using a video camera was then performed after flushing and pumping of the zone to visually observe the repair process, which showed almost complete removal of the defective concrete. The zones were then filled with 40 MPa neat cement grout. This procedure was repeated for each zone starting from the lower zone to the upper zone.

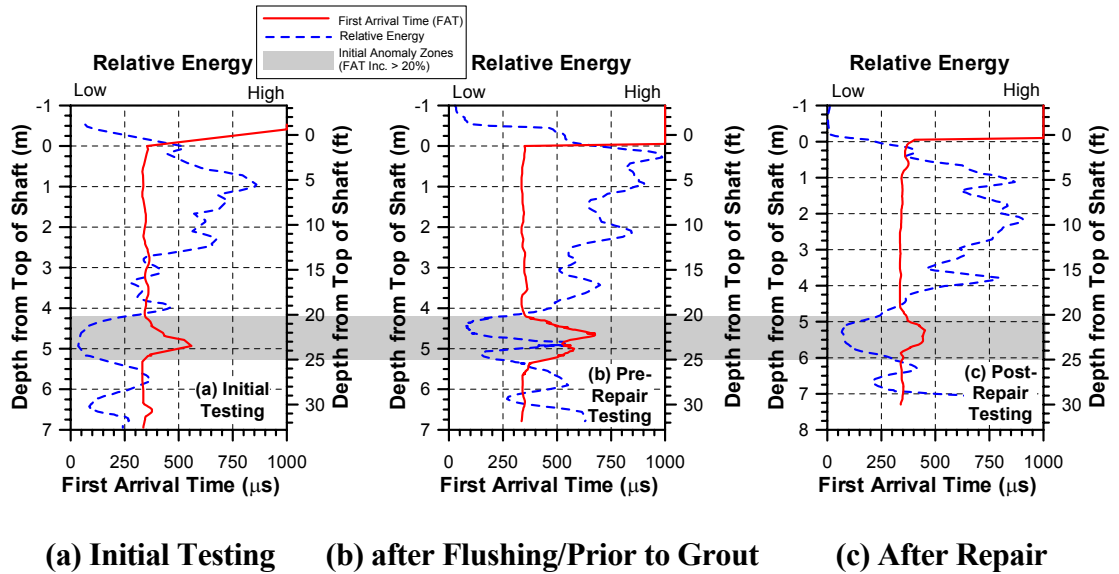
Figure 7. CSL Testing Results with Depth for Case History 2 (Profile 2-6).

The initial CSL/CT testing indicated a significant anomalous zone approximately 9 to 10 meters below the top of tubes (4.9 to 5.9 m below top of concrete), defined by increases in FATs typically from 15% to 25% and associated reductions in relative

energy. The FAT increases correlated to reductions in apparent velocity of ~20% or more from the nominal value in the non-anomaly zones. Increases in FATs from 40% to 50%, with associated large reductions in energy were observed in tube combinations within the southwestern portion of the socket (tube 1 is north). The FAT increases correlated to reductions in apparent velocity of ~30-35% or more from the nominal value in the non-anomaly zones. Figures 7a and 8a present the initial CSL and CT testing with depth, respectively. Figure 8a also presents the horizontal tomographic slice through the anomaly zone.

The repair procedure involved using a high pressure nozzle to blast out concrete in the defective zone from the three access holes. Nozzle pressures upwards of 70 to 105 MPa were used to cut away the defective concrete at the top and below the suspect zone. Lower pressures were used to remove the sand/aggregate material in the middle to bottom of the defective zone. Remote inspection using a video camera was then performed after flushing and pumping of the zone to visually observe the repair process, showing that significant removal of the defective concrete was achieved leaving higher quality concrete in-place. After the flushing process was completed and prior to

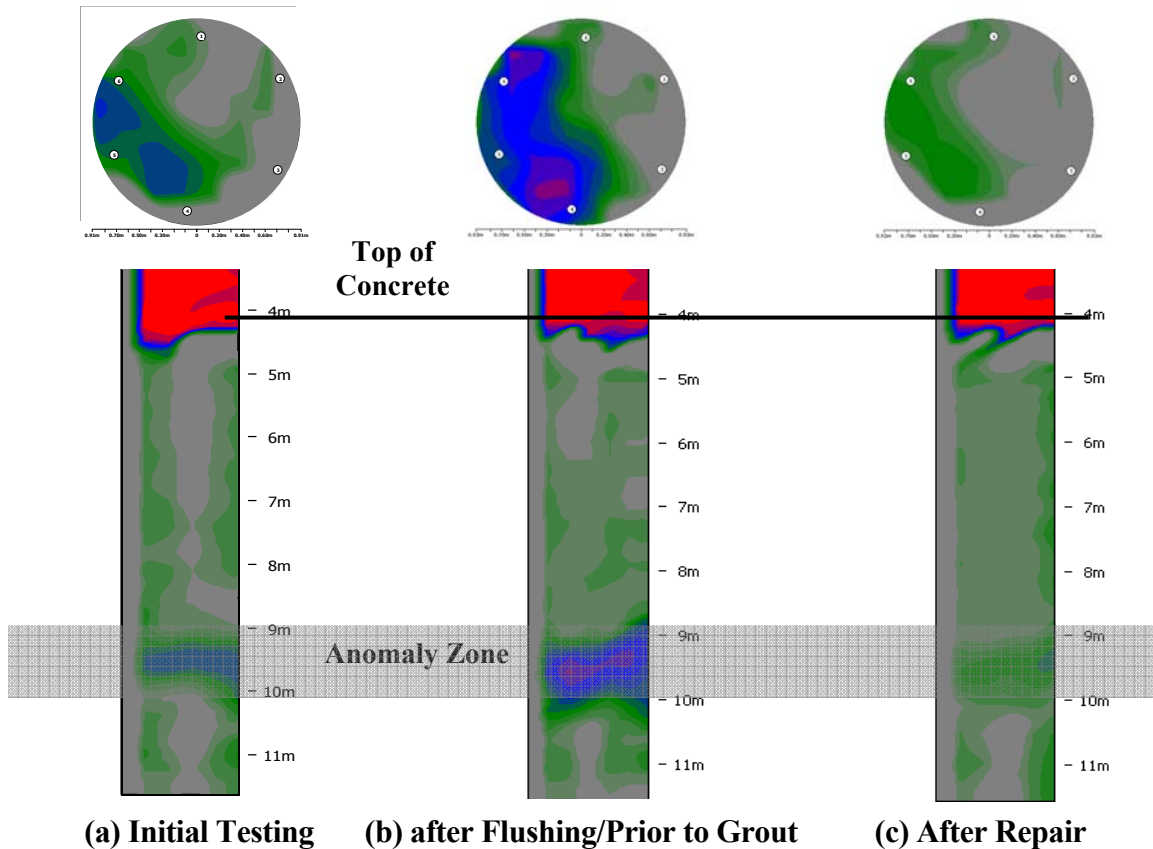
Figure 8. 2D Vertical and Horizontal CT Results for Case History 2 (Profile 2-6).

grouting, CSL/CT testing was performed again to characterize and define the water filled flushed out zone (see Figures 8b and 9b, respectively). The CSL/CT results at this stage indicated that the poor material was removed and the remaining void was filled primarily with water (wave speed around 1,500 to 2,000 m/s represented by red & blue areas).

The flushed out zone was then filled with 28 MPa neat cement grout. The grout was delivered under pressure using packers inserted and sealed off within two core holes. The grout was pumped until consistent return was observed flowing through the third open core hole. The 7-day grout compressive strengths ranged between 29 and 32 MPa. CSL/CT testing was performed three days after grouting for use as a comparison with the initial and pre-grouting CSL/CT test results. CSL and CT results for the post repair testing are presented in Figures 8c and 9c, respectively. As shown in Figures 8 and 9, improvements with respect to velocity and relative energy were observed in the repaired zone between initial and post-repair testing. The primary velocity in the post-repair grouted zone was around 3,000 m/sec compared to the typical value of 3,800 m/sec for the concrete above and below the repair zone. The 7-day grout compressive strengths were approximately 30 MPa. Based on the CSL/CT results in conjunction with QC/QA testing of the grout materials, the drilled shaft repair was considered to be successful.
