ACTIVE SOIL NAIL WALL UNDERPINNING SOLUTION FOR THE BRUCE MUSEUM PROJECT

Jonathan L. Ernst, P.E., Geosciences Testing and Research, Inc., North Chelmsford, MA, USA
Les R. Chernauskas, P.E., Geosciences Testing and Research, Inc., North Chelmsford, MA, USA
Martin B. Hudson, Ph.D., P.E., Turner Construction Company, Los Angeles, CA, USA
Rolff B. Knobel, Turner Construction Company, Shelton, CT, USA
Andrew K. Cho, Ph.D., P.E., P.G., Turner Construction Company, New York, NY, USA

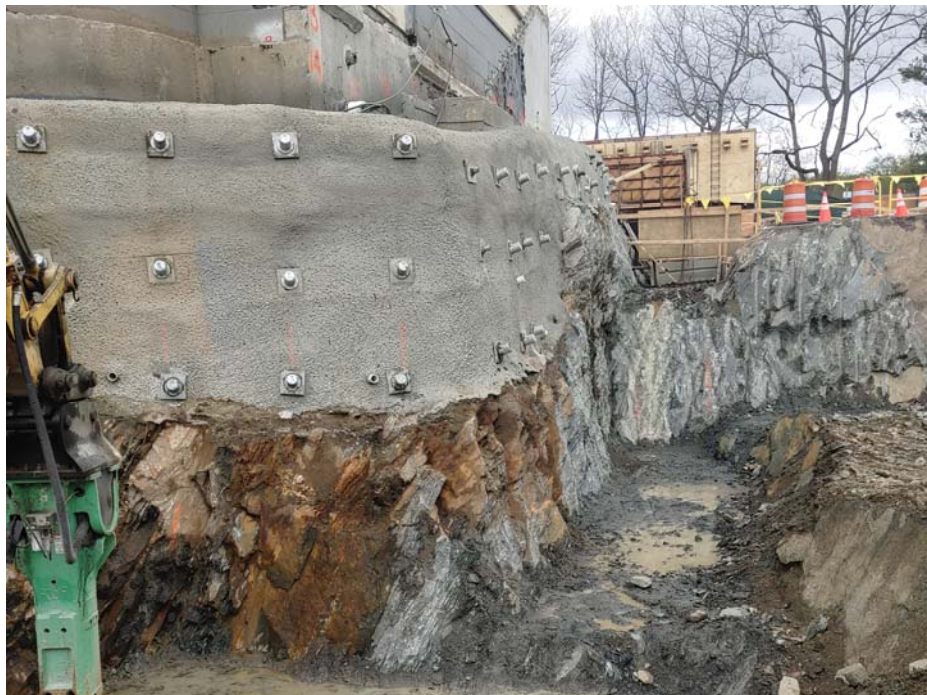
Figure 2: Photo of soil nail wall facing above excavated rock face.

The depth to rock was variable across the site, and in turn, variable depths of soil nail wall were needed below the existing foundations to reach the top of rock. A soil nail wall could effectively be terminated at the top of rock, while the nail spacing was maintained (see Figure 1). Although the soil nail wall would be terminated at the top of the rock, the excavation was to continue to around ± 16 feet below the bottom of existing footings. A rock shelf in front of the soil nail facing was proposed to support the soil nail facing, while the excavation continued below to the proposed footing depths. See photo in Figure 2 for an example of the soil nail excavated face at the required excavation depth. To facilitate the excavation of rock, rock below grade was line drilled by the contractor in several areas to the bottom of footing elevation just outside the proposed footing footprint. This allowed the rock to be excavated with limited disturbance to the rock beneath the existing footings and soil nail wall.

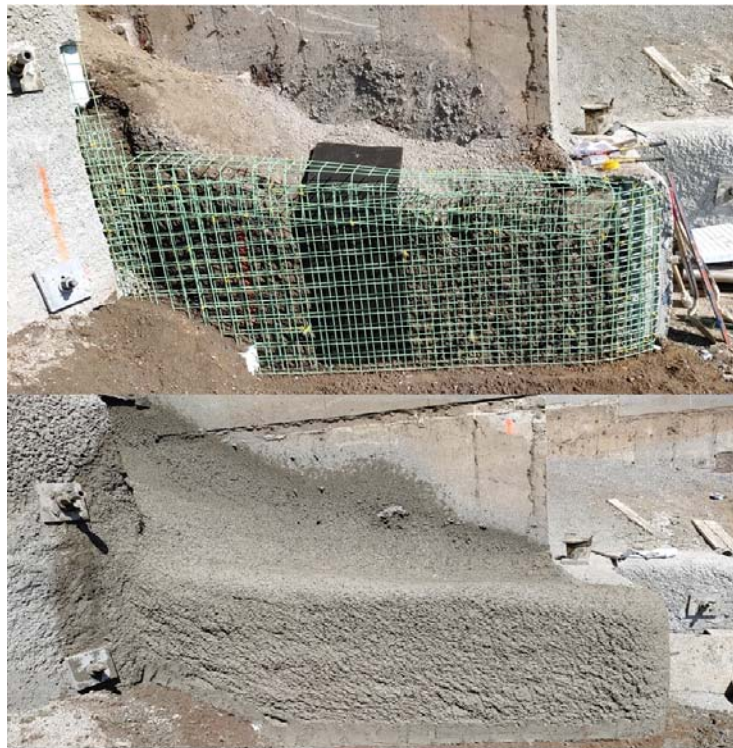
Figure 4: Shotcrete facing – rebar installation and shotcrete placement

Facing rebar and shotcrete was assembled and installed on the same day excavations were performed to reduce soil loss before the soil nails were installed for each lift and sequence section. After soil nails were installed, each soil nail was locked off at 50% of the design load to create an active condition. The lock off sequence also was considered a form of modified proof testing of each soil nail. See Fig 4 for facing construction (wire mesh installation and shotcrete placement).

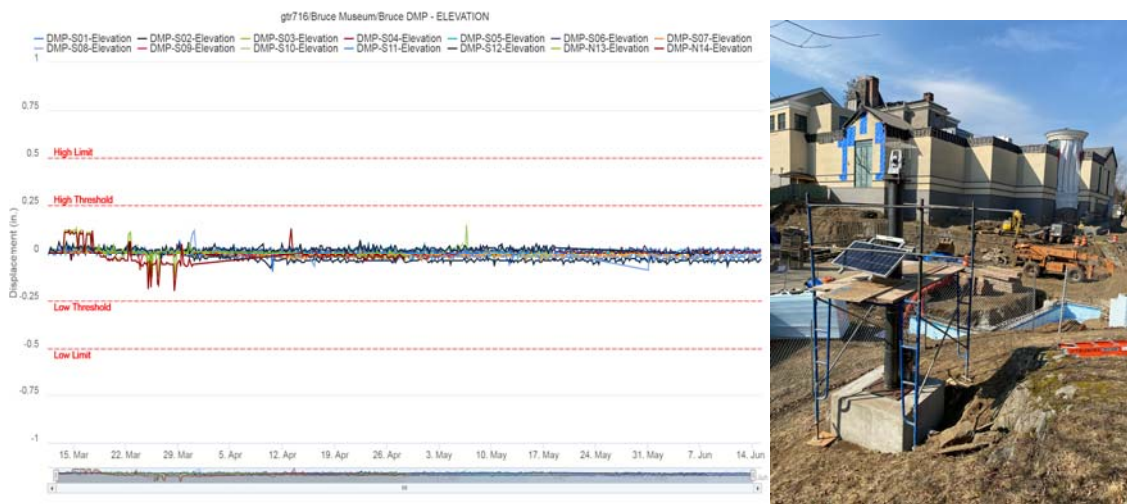
Figure 5: Elevation data of existing structure behind soil nail wall through the monitoring program and one of the AMTS setups at the project.

GTR observed and documented all soil nail testing, including 4 verification tests and 7 proof tests, to confirm the soil and rock bond stresses were consistent with our design methodology. To confirm there was limited movement of the wall and the existing structure, GTR’s Automated Deformation Monitoring program was implemented using two automated robotic total stations (AMTS), accurate to 1 second (vertical and horizontal) with an accuracy of 0.05 inches at 1000 feet (using optical survey prisms and total station) – see Figure 5. Deformation monitoring points installed on the existing structure showed minimal northing, easting and elevation fluctuations throughout construction and after the completion of the soil nail wall, confirming the soil nail wall was performing as intended. Figure 5 shows the elevation changes of the existing structure above the underpinning elevations throughout the monitoring program of the Project.
