## **Performance Verification of Constructed Geotechnical Facilities**

*Amherst 2000: Geoinstitute / ASCE Specialty Conference*

# **Defect Detection and Examination of Large Drilled Shafts Using a New Cross-Hole Sonic Logging System**

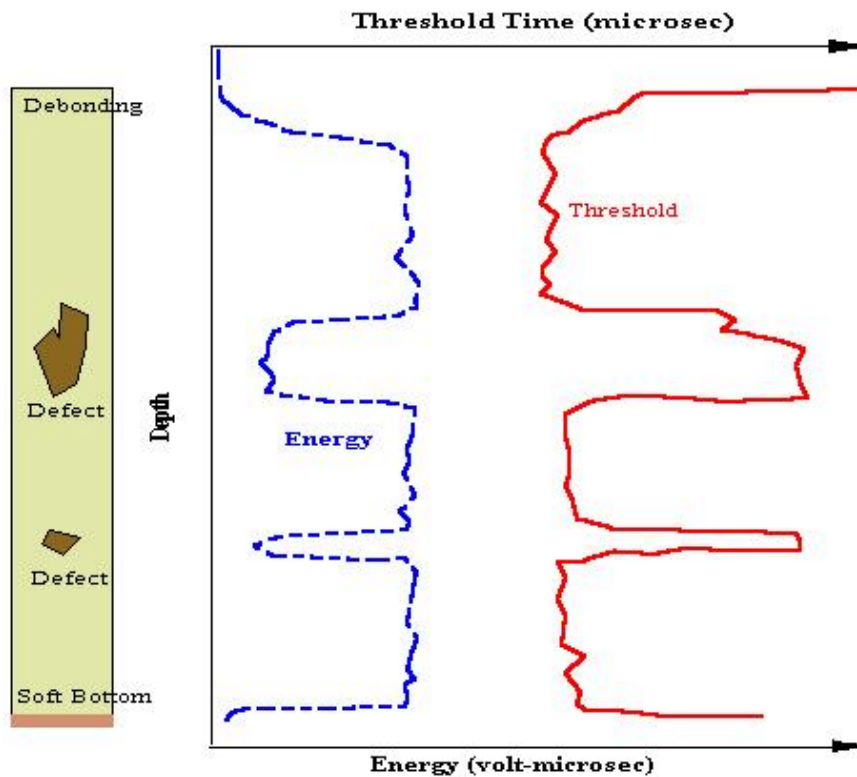
**Figure 3 Presentation of CSL Test Results in the Form of Threshold Time and Energy Verse Depth**

This is, of course, only a rough estimate, as the picking of the arrival time,  $t$ , is not objective and the distance between the tubes,  $L$ , is only known at the top of the shaft. The signal arrival times can then be plotted with depth to generate a log for the particular tube combination as presented in Figure 3. In addition to the threshold times, the energy of each signal may also be plotted with depth. This information can be used to compare signals of one zone to another where lower energy and/or later arrival times correspond to a compromised concrete quality and/or defect.

Advantages to this method include the direct assessment of pile integrity and the ability to position the transducers in different elevations to create more signals, allowing the development of a tomographic presentation of the investigated zone. The limitations of the method include detection of defects only when they exist between the tubes. The testing can be performed only on drilled shafts for which access tubes were installed. Debonding between the tubes and concrete is common if testing occurs long after the concrete placement. Testing in fresh concrete is also difficult as certain zones may cure at a lower rate, creating difficulties in the interpretation of the threshold time and energy. These zones may therefore be interpreted as poor quality concrete.

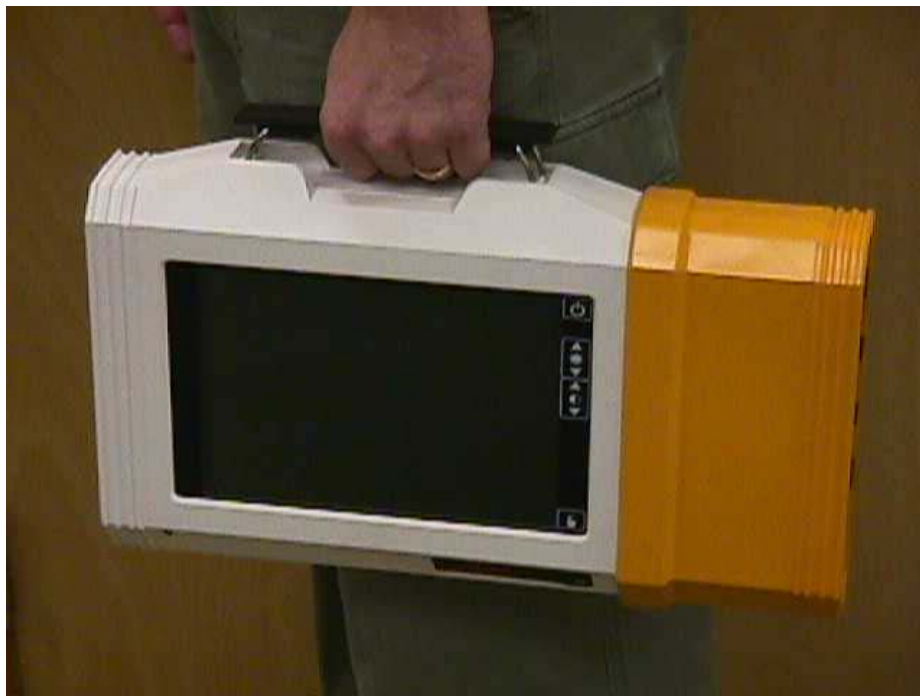
**Figure 5 Photograph of the Pile Integrity Sonic Analyzer (PISA)**

Figures 5 through 7 present photographs of the PISA system, including computer and sensors. Figure 8 presents the layout of the pile screen, where one can enter the pile information and select the tube orientation/locations. Selection of the desired tube combinations is accomplished by drawing a line between any two tubes. Figure 9 presents the data collection screen, where real-time graphical presentation of the concrete integrity is provided during testing. If a suspect zone is detected in this stage and the tomography option is enabled, the probes are lowered and raised relative to each other around the suspect zone, to further investigate and delineate the area. The signals can be examined and adjusted by manually picking the points or using preset algorithms to automatically determine the first arrival time (FAT) as shown in Figure 10. Figure 11 represents the typical graphical output for time and energy plots.

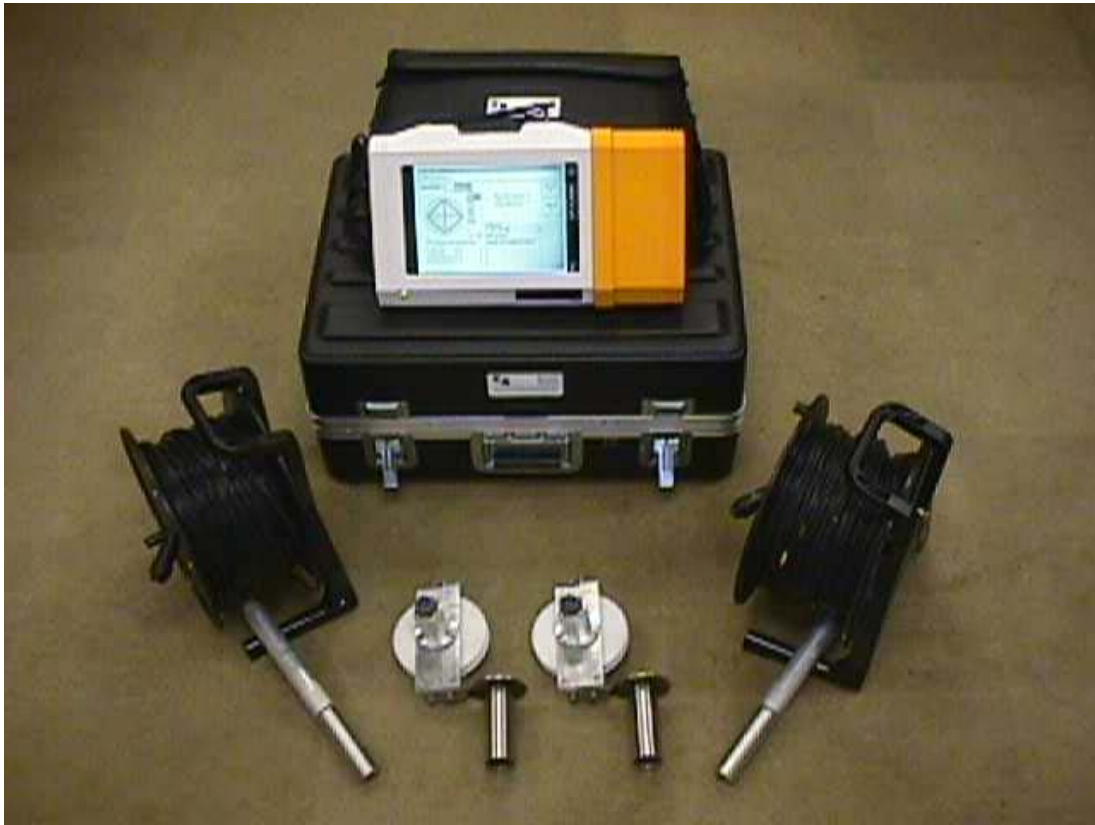
Figure 6 PISA System Components

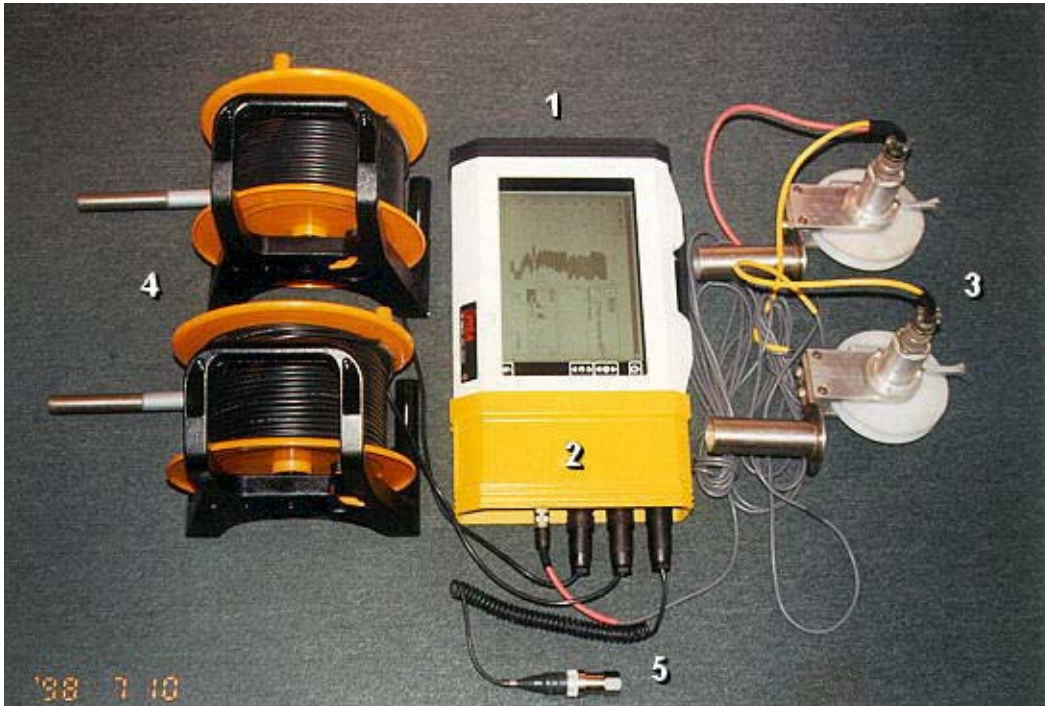
Figure 7 PISA System with CHUM and PET Modules

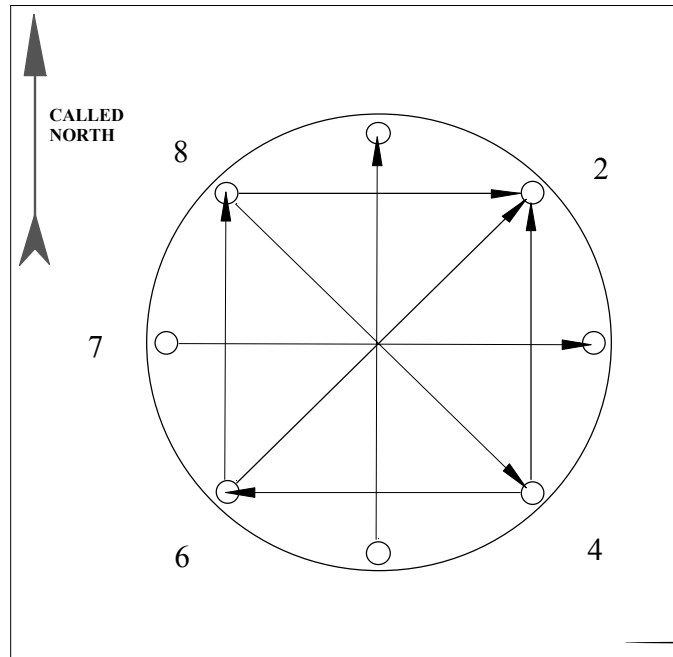
**Figure 12 CSL Tube Layout**

Eight schedule 80 PVC CSL access tubes were attached to the reinforcement cage and placed within the shaft prior to the placement of the concrete. The tubes were filled with water prior to placement in the shaft. CSL testing was performed primarily along the four diagonal tube combinations and four edge tube combinations as shown in Figure 12. Additional testing was performed as needed depending on the results.

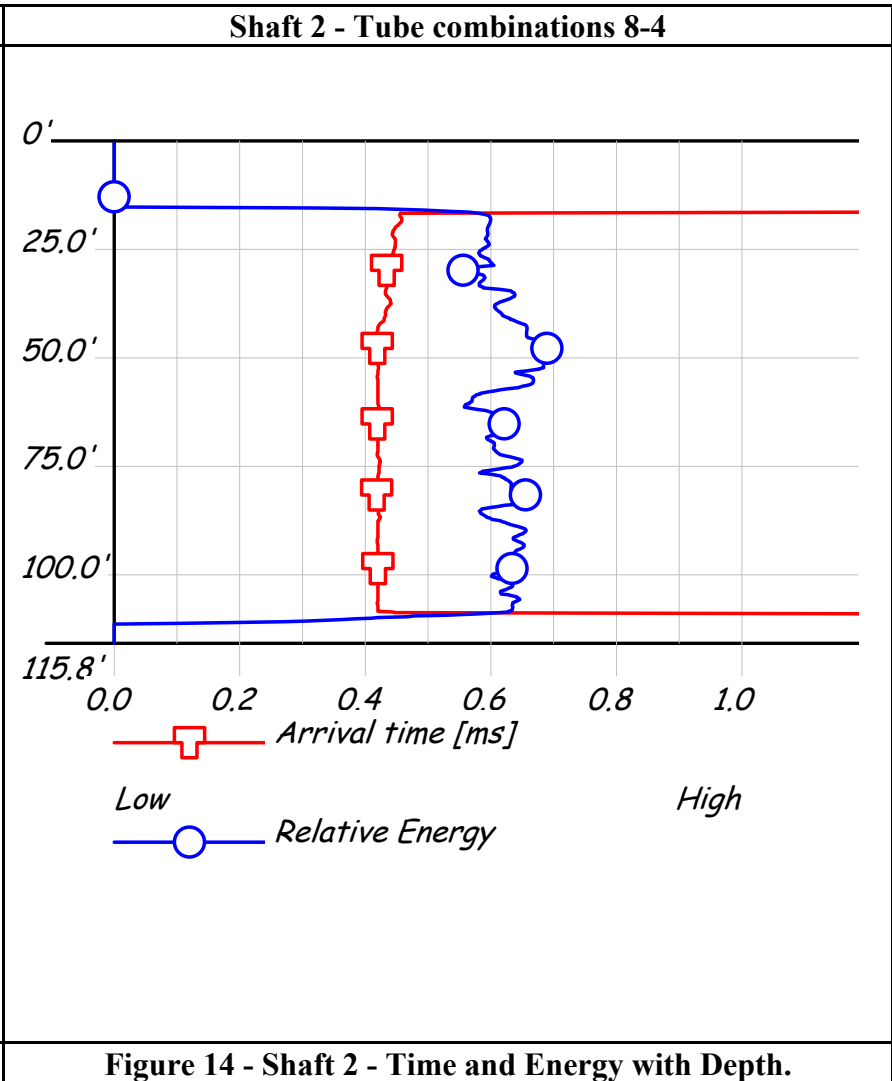
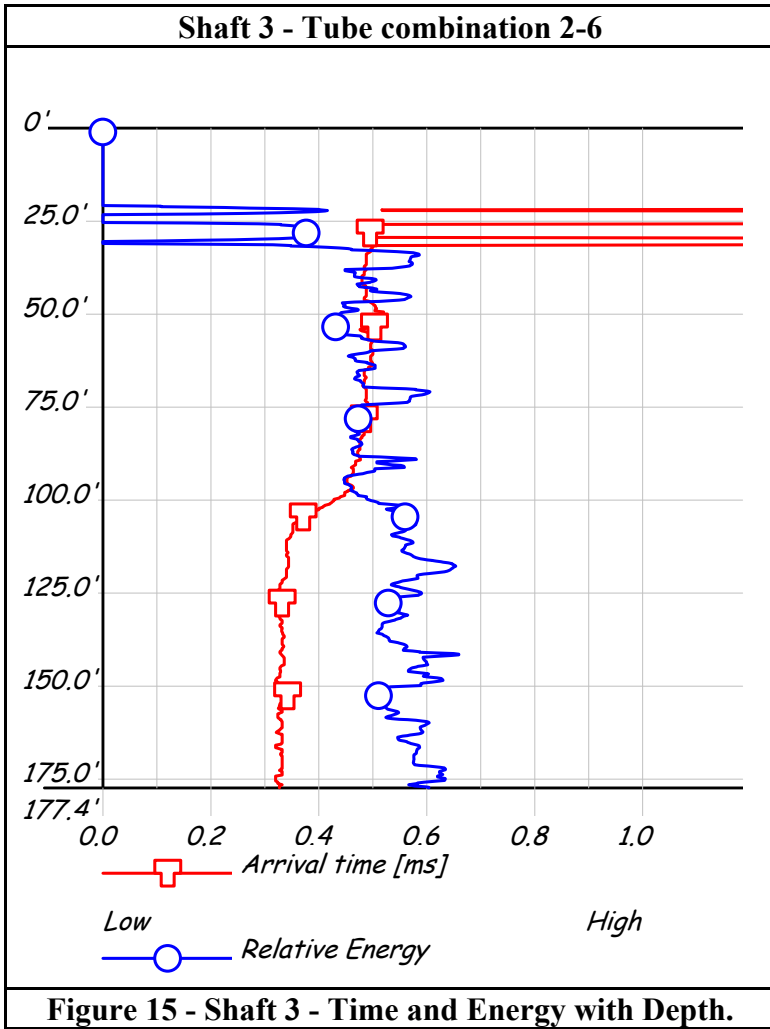
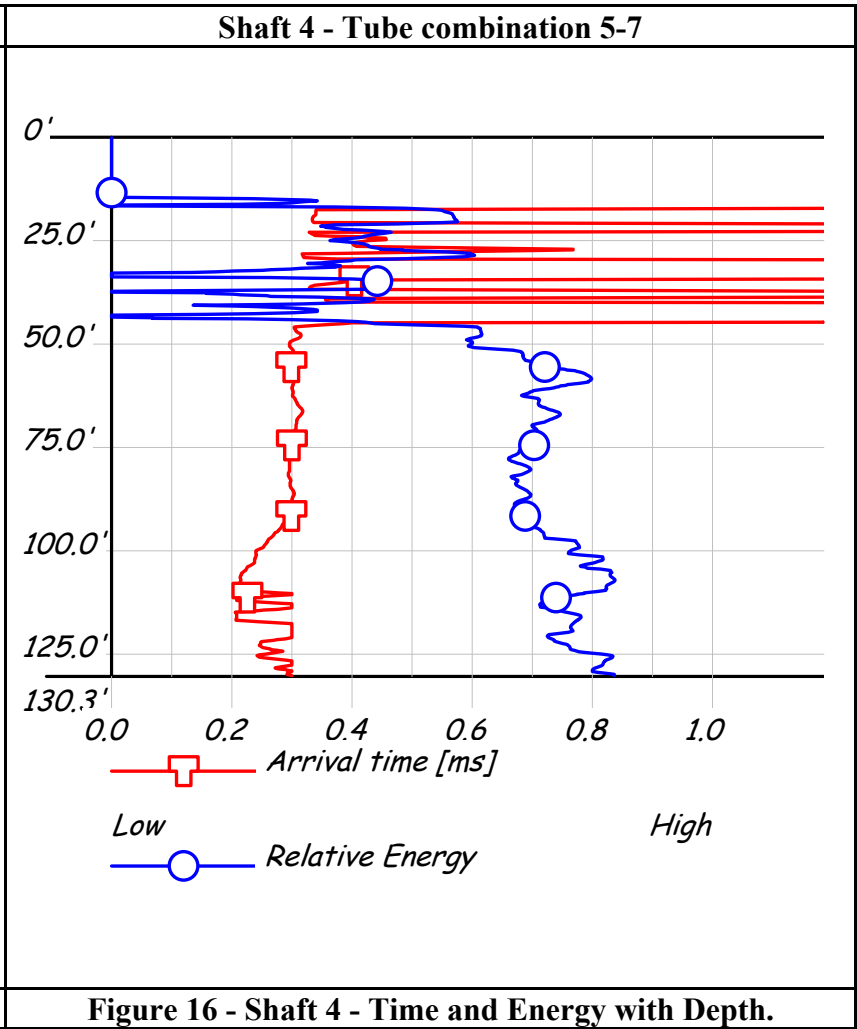
The CSL testing indicated significant anomalies in four of the first group of shafts installed for phase 1. Typical time and energy plots for the shafts (designated as "1 through 4") showing the various anomalies, are presented in Figures 13 through 16, respectively. The presented data illustrate two soft bottoms (shafts 1 and 2) and two problems in the upper 12.2 m (40 ft) (shafts 3 and 4). Table 1 summarizes the results of the repeated CSL testing performed for all four shafts. Following the testing and outline of anticipated problematic zones, a coring program was undertaken to verify the identified anomalous zones. For shafts 1 and 2, one 10.16-cm (4-in) core was drilled down the center of each shaft into the underlying bedrock. For shafts 3 and 4, multiple cores were taken between 6 m (20 ft) and 9 m (30 ft) as shown in Figures 17 and 18, respectively. The lateral extent of the suspect zones as identified by the CSL testing is presented in the two figures.

The concrete core samples retrieved from the suspect zones in shafts 1 (lower 6.1 m (20 ft)) and 2 (lower 2.4 m (8 ft)) were completely raveled, segregated, and disintegrated suggesting major discontinuity in the lower section of the shaft. The beginning of the defective concrete obtained from the coring coincided closely with the suspect zone identified during the CSL testing. These two shafts are currently undergoing repair procedures to transfer the loads through the defective zone to the underlying rock below.
