Saving a Bridge Foundation

LES CHERNAUSKAS, P.E., Geosciences Testing and Research, Inc., North Chelmsford, MA

PETER CONNORS, P.E., Massachusetts Department of Transportation, Boston, MA

IBC 17-66

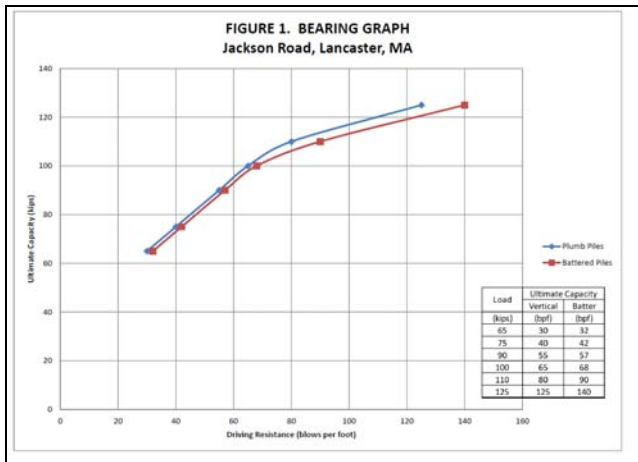
Figure 6. Wave Equation Bearing Graph

3. Perform wave equation analyses to develop blow count vs resistance relationships using the results of the analyses in Step 2. Several cases were performed based on penetration length, percent end bearing, and hammer efficiency (vertical vs batter pile) variations. For the range of blow counts recorded, the resulting wave equation back-calculated resistances ranged from 65 to 125 kips. Figure 6 shows the relationship between blow count and capacity (nominal resistance) for one case.

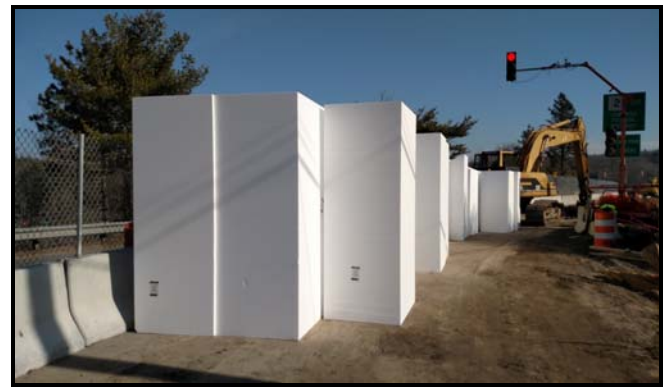
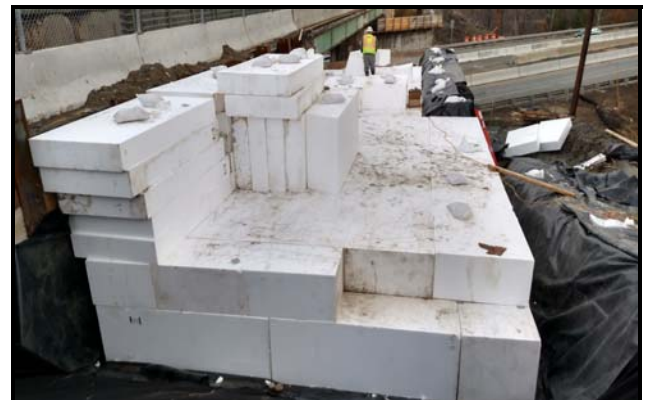
Figure 9a, 9b, and 9c Geofoam for Abutments

The pier factored resistances exceeded the factored axial loads for most piles and overall for the total group. Some of the abutment piles were overloaded considering the new load combinations and dead weight of the backfill. In order to reduce the dead loads on the abutments, Geofoam lightweight fill was used. Figures 9a through 9c show the Geofoam fill design and on-site placement.

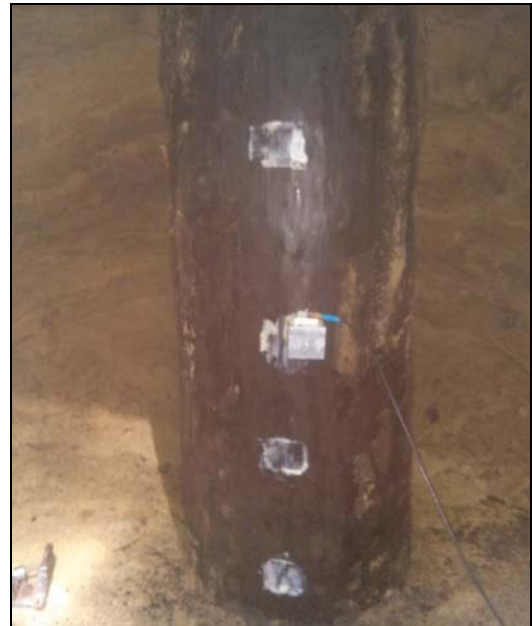
Figure 10a, 10b, 10c. Pile Investigation and NDT

Overall, the exposed timber piles in the test

pits appeared to be in pristine condition, based on visual observation, core samples, resistograph testing, and non-destructive integrity testing. Figures 10a through 10c provide a typical photo of the timber piles, sonic echo integrity testing results, and resistograph testing results, respectively.

- 1) Visual observation,
- 2) Core testing and evaluation,
- 3) Resistograph testing, and
- 4) Sonic Echo Method integrity testing to confirm length.
